DECEMBER 2022

EZULWINI NORTH TAILINGS  
 STORAGE FACILITY (TSF)

DETAILS OF TAILINGS STORAGE FACILITY

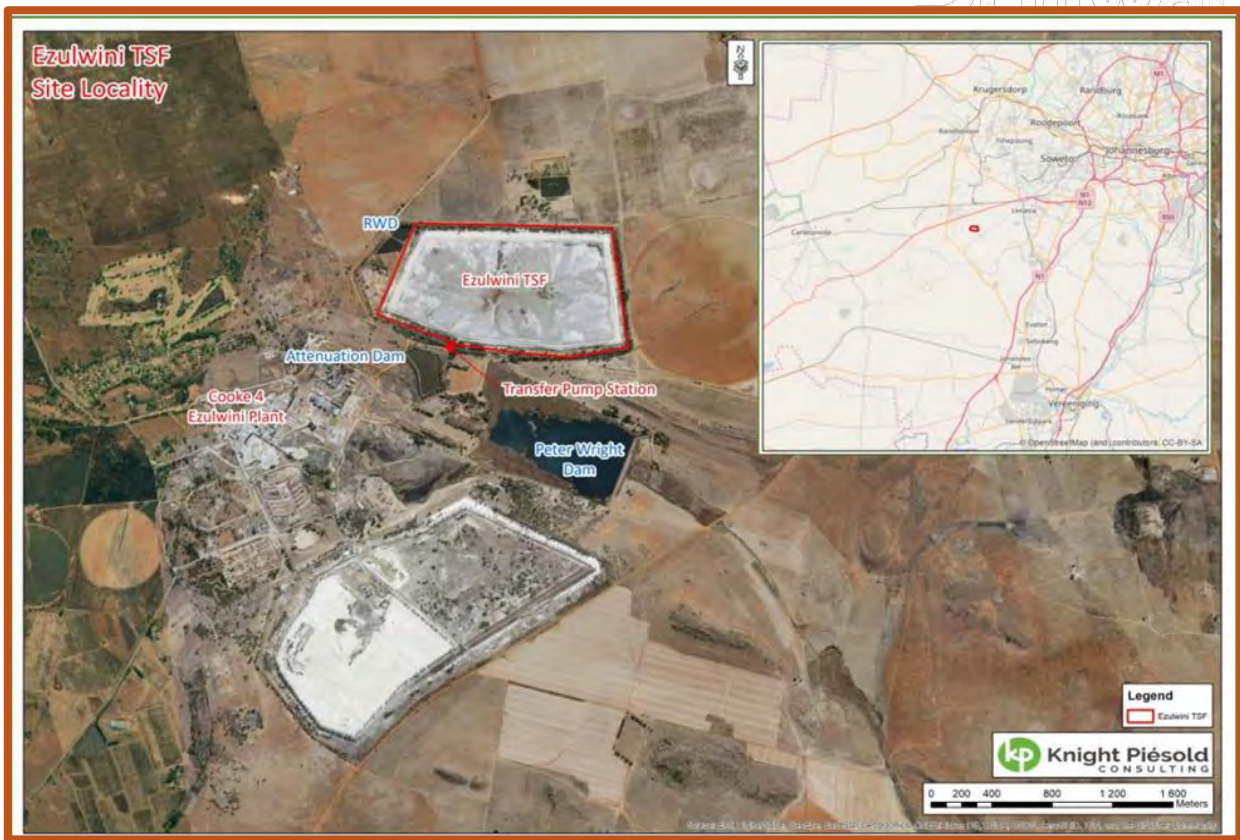
Figure 1: Layout of Ezulwini (Cooke 4) TSF Complex

Tailings Storage Facility (TSF) Name	Ezulwini North TSF (Cooke 4)
Operation	Cooke 4
Operational Status	Active
Operating Segment	RSA - Gold
Location	Cooke 4, Ezulwini in Westonaria, South-west of Johannesburg - please refer to Figure 1
Latitude, Longitude (decimals)	-26.35345, 27.7256778
Ore Source	Underground
Type of Storage Facility	Impoundment (upstream development)
Deposition Methodology	Day-Wall Paddock
Year of Commissioning	1982
Consequence Classification (GISTM, 2020)	Extreme
Operating Contractor	Stefanutti Stocks Inland (SSI)
Engineer of Record (EoR)	Knight Piesold (Pty) Ltd (KP)
Current Maximum Height (m)	30
Final Maximum Height (m)	60
Maximum Storage Capacity (tons/month)	200 000
Life of TSF (year)	2035 @2m/year

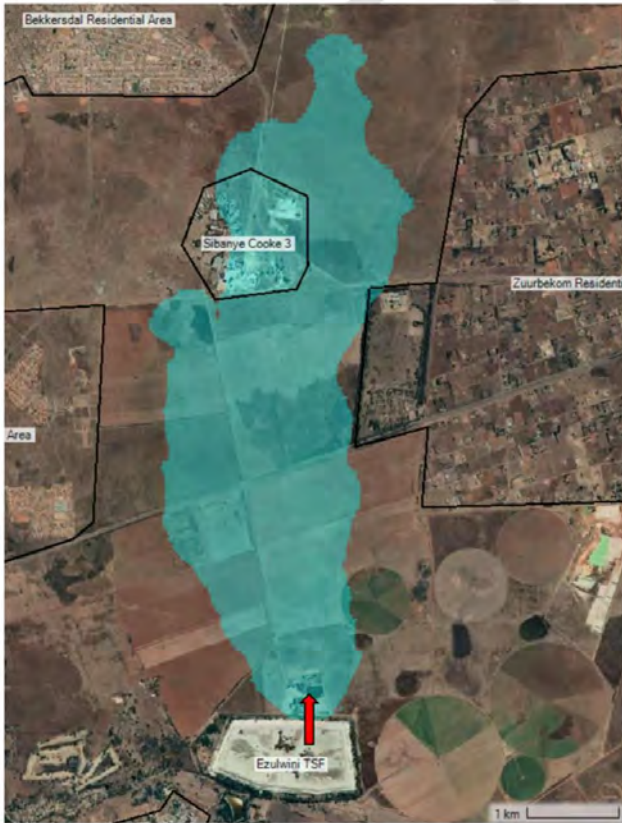
Figure 2: Inundation Map for the Rainy-day Failure at the Northern Wall

Has been identified by EoRs – please refer to Figures 2 to 5

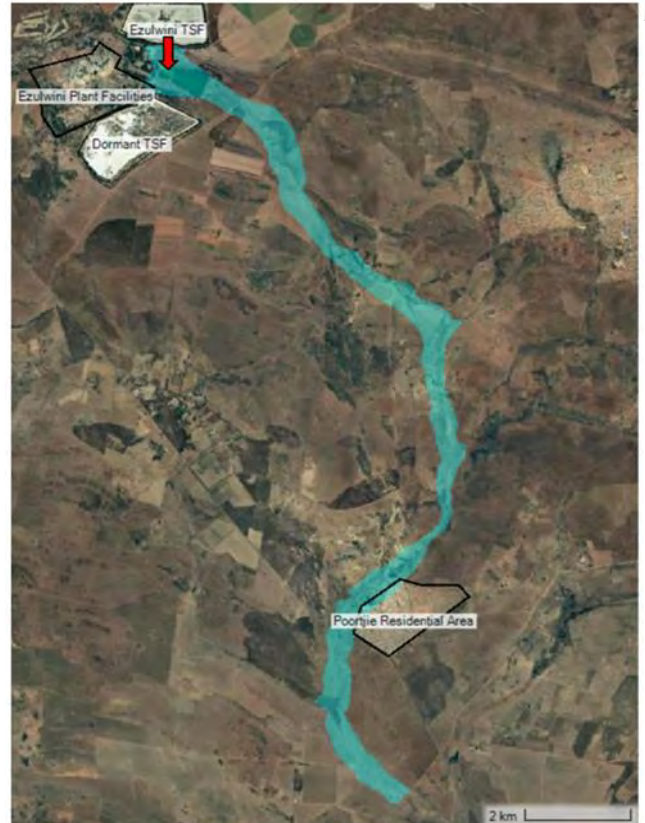
Figure 3: Inundation Map for the Rainy-day Failure at the Southern Wall

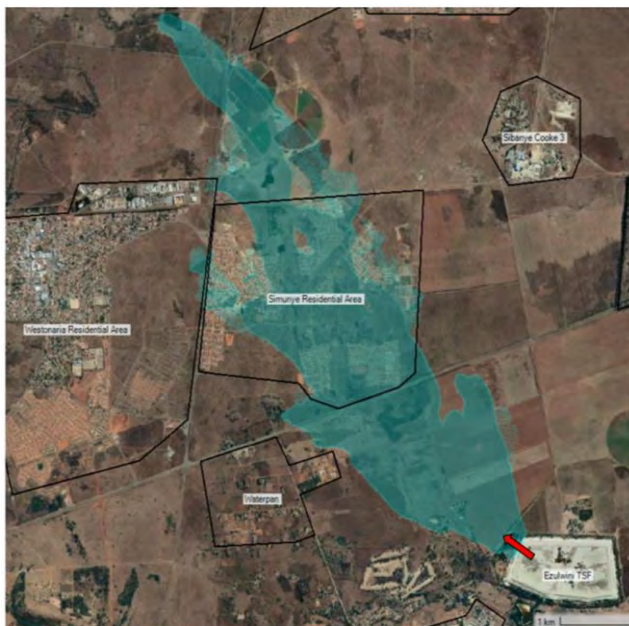
Figure 4: Inundation Map for the Rainy-day Failure at the North-Western Wall

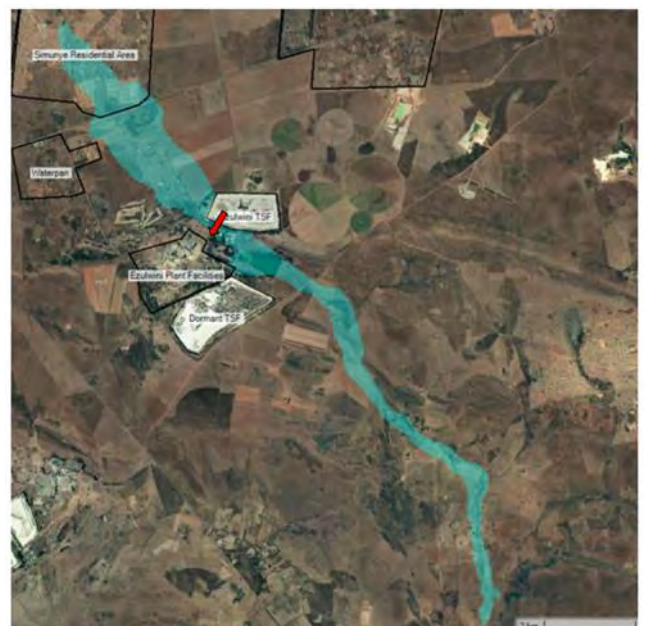
Figure 5: Inundation Map for the Rainy-day Failure at the South-Eastern Wall
