DECEMBER 2023

EZULWINI NORTH TAILINGS STORAGE FACILITY (TSF)

DETAILS OF TAILINGS STORAGE FACILITY

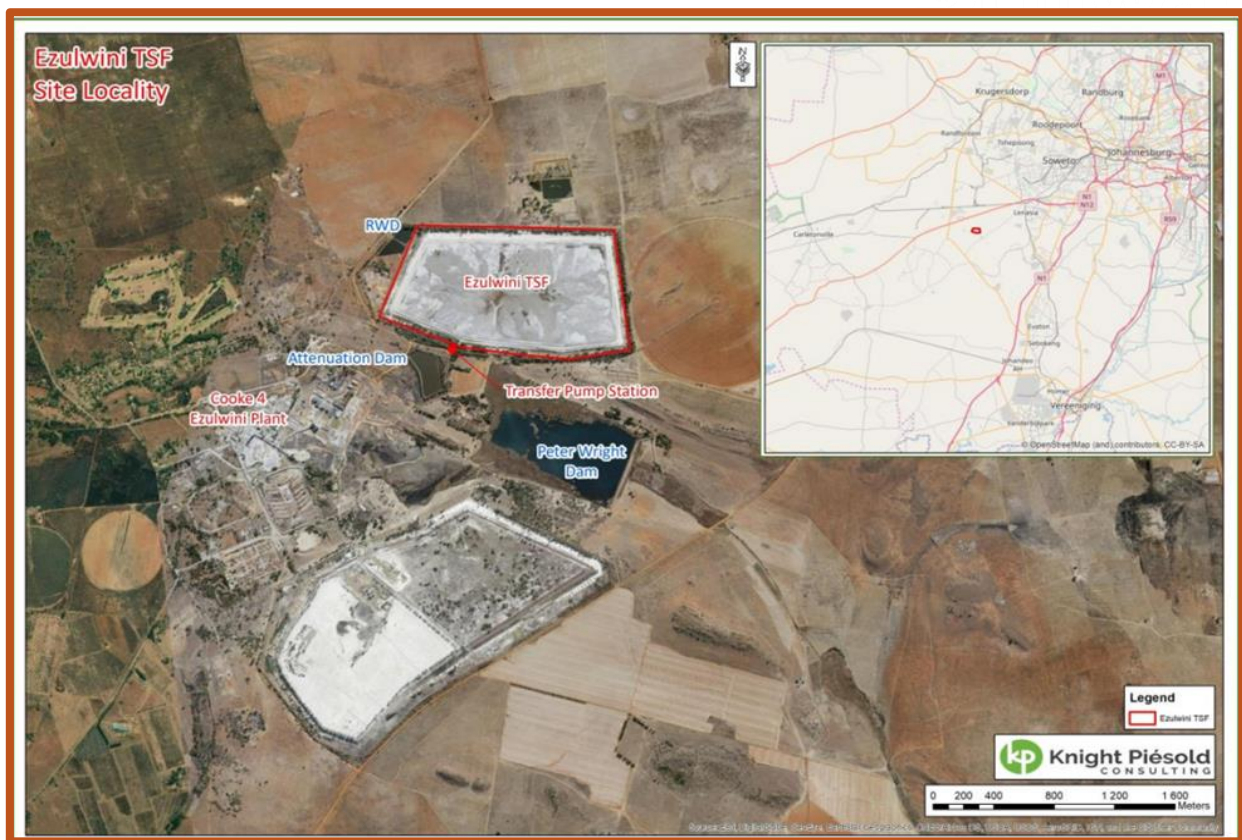
Figure 1: Layout of Ezulwini (Cooke 4) TSE Complex

Tailings Storage Facility (TSF) Name	Ezulwini North TSF
Operation	Cooke 4
Operational Status	Active
Operating Segment	RSA - Gold
Location	Westonaria, South-west of Johannesburg - please refer to Figure 1
Latitude, Longitude (decimals)	-26.35345, 27.7256778
Ore Source	Underground
Type of Storage Facility	Impoundment (upstream development)
Deposition Methodology	Day-Wall Paddock
Year of Commissioning	1982
Consequence Classification (GISTM, 2020)	Extreme
Operating Contractor	Stefanutti Stocks Inland (SSI)
Engineer of Record (EoR)	Knight Piesold (Pty) Ltd (KP)
Current Maximum Height (m)	30
Final Maximum Height (m)	60
Maximum Storage Capacity (tons/month)	200 000
Total Volume Already Deposited (Mm³)	26.7
Life of TSF (year)	2035 @2m/year

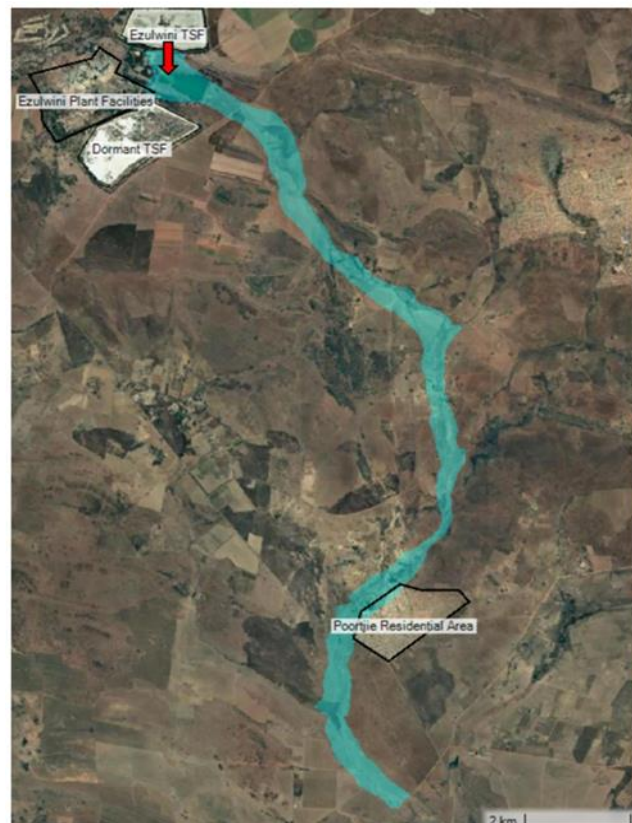
Figure 3: Inundation Map for the Rainy-day Failure at the Southern all

Has been identified by EoRs – please refer to Figures 2 to 5

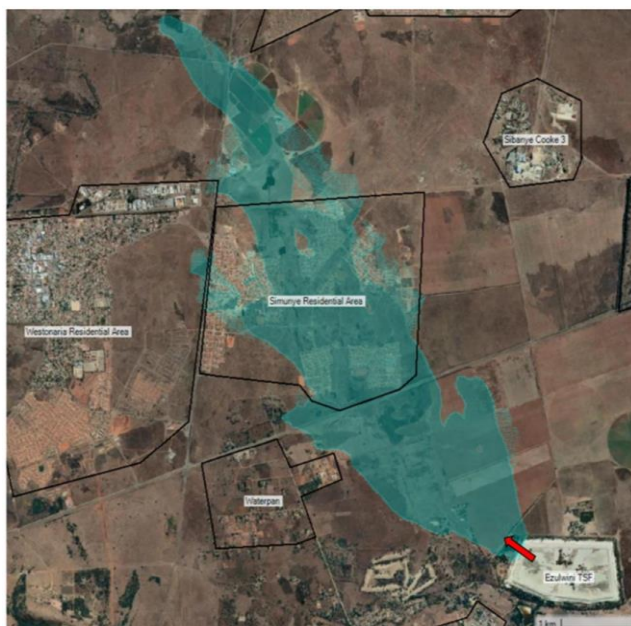
Figure 4: Inundation Map for the Rainy-day Failure at the North-Western Wall

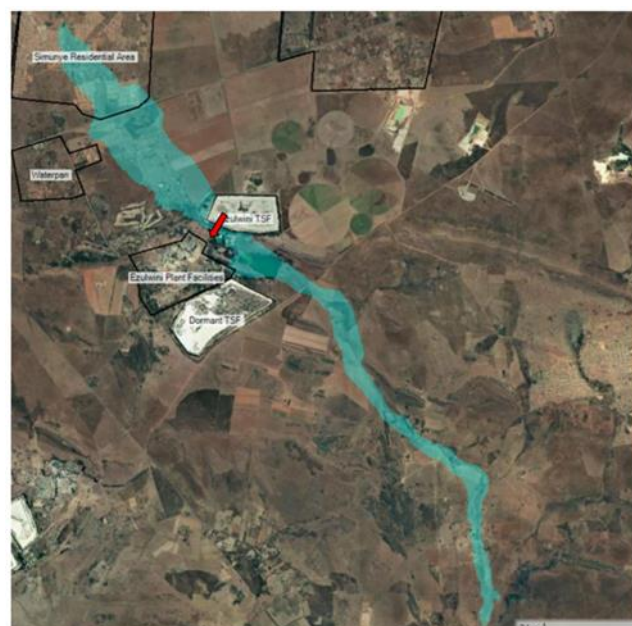
Figure 5: Inundation Map for the Rainy-day Failure at the South-Eastern Wall
