DETAILS OF TAILINGS STORAGE FACILITY

Karee Mine K4 Concentrator TSF 1

Operation Marikana

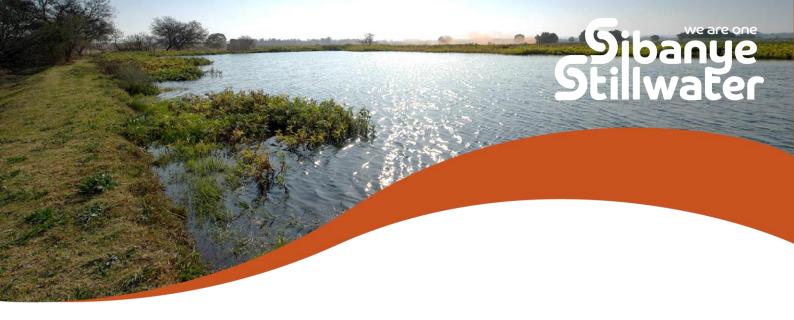
Figure 2: Area of Inundation (North-East tributary)

Has been identified by EoRs – please refer to Figure 2

Dam Breach Assessment

Area of Inundation
