4 August 2025

GLOBAL INDUSTRY STANDARD FOR TAILINGS MANAGEMENT – DECLARATION OF CONFORMANCE

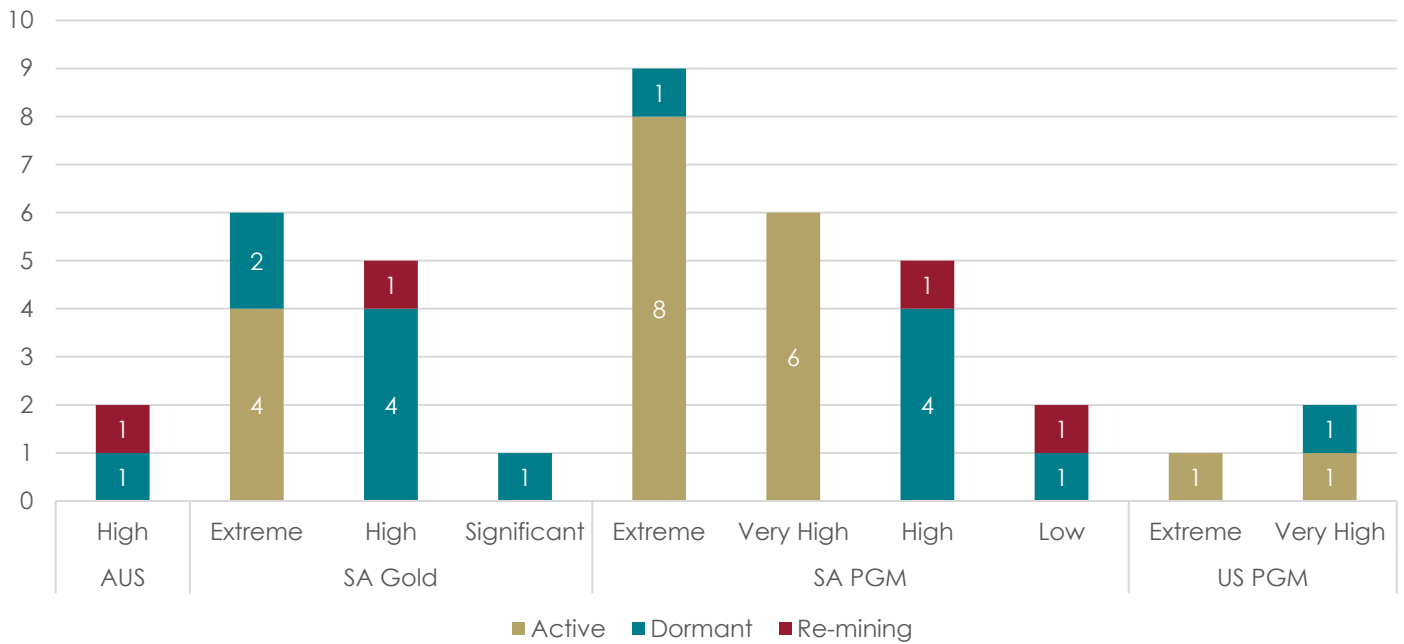
FIGURE 1-1: SIBANYE-STILLWATER TSFs

The TSFs owned and managed by Sibanye-Stillwater are depicted in Figure 1-1. For further details, including TSF-specific Fact Sheets, please refer to the following link: <https://www.sibanyestillwater.com/sustainability/environment/tailings-management/>. The Fact Sheets provide comprehensive insights into the management, classification, and operational status of each facility.

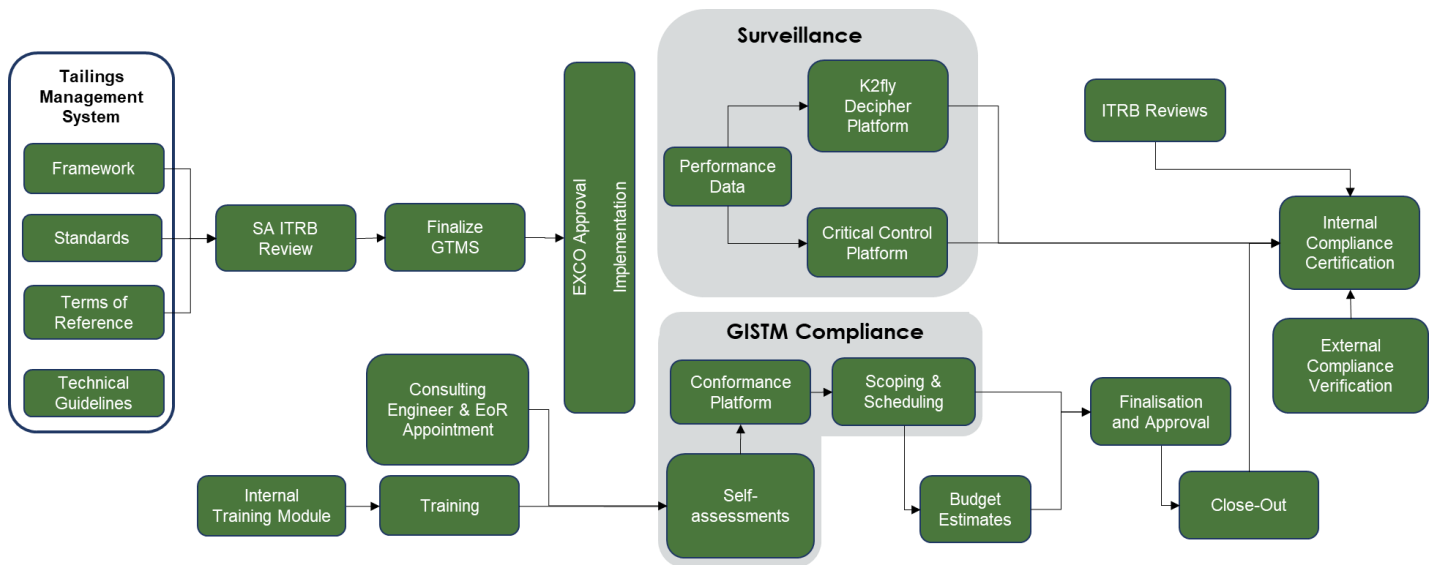
FIGURE 2-1: CONFORMANCE ROADMAP

A schematic of the roadmap is included in Figure 2-1.
