# TAILINGS STORAGE FACILITY - TAILINGS OPERATIONS, MAINTENANCE AND SURVEILLANCE (TOMS) MANUAL

## East Boulder Mine

### Tailings Storage Facility - Tailings Operations, Maintenance and Surveillance (TOMS) Manual

2026/04/13

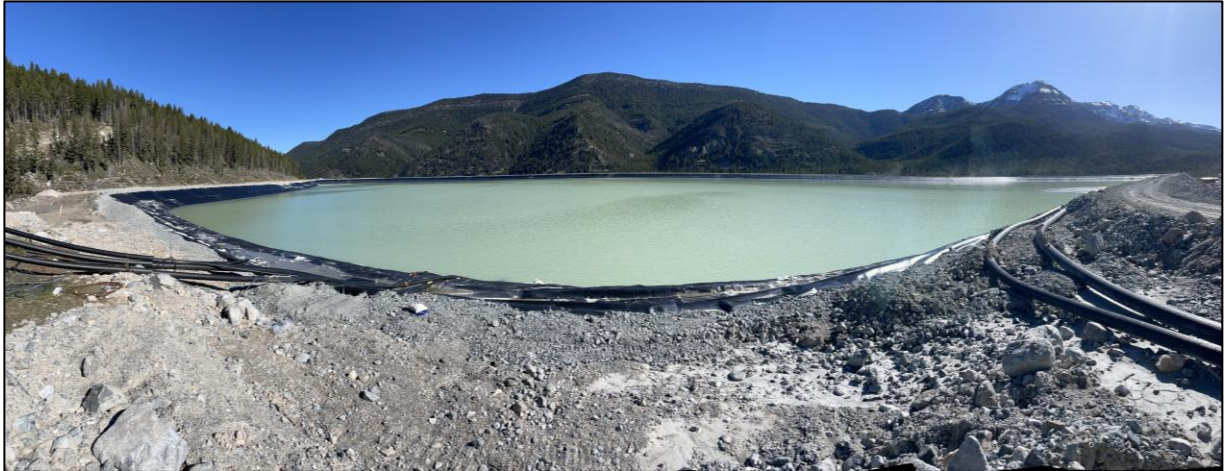
**PHOTO 1** - TSF overview from South Embankment corner looking north (May 2024).

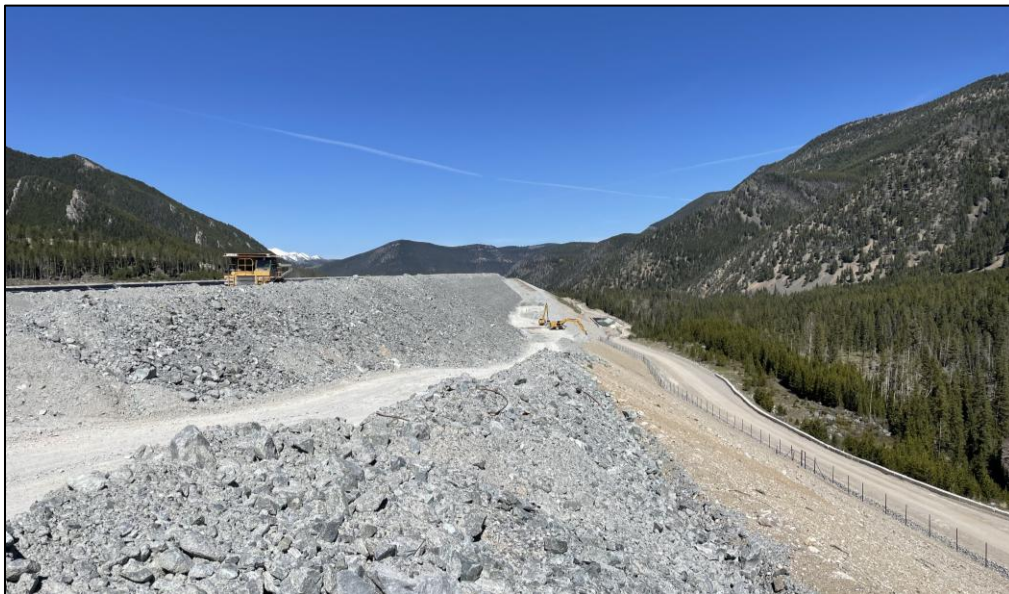
**PHOTO 2** - North Embankment downstream slope looking northwest (May 2024).

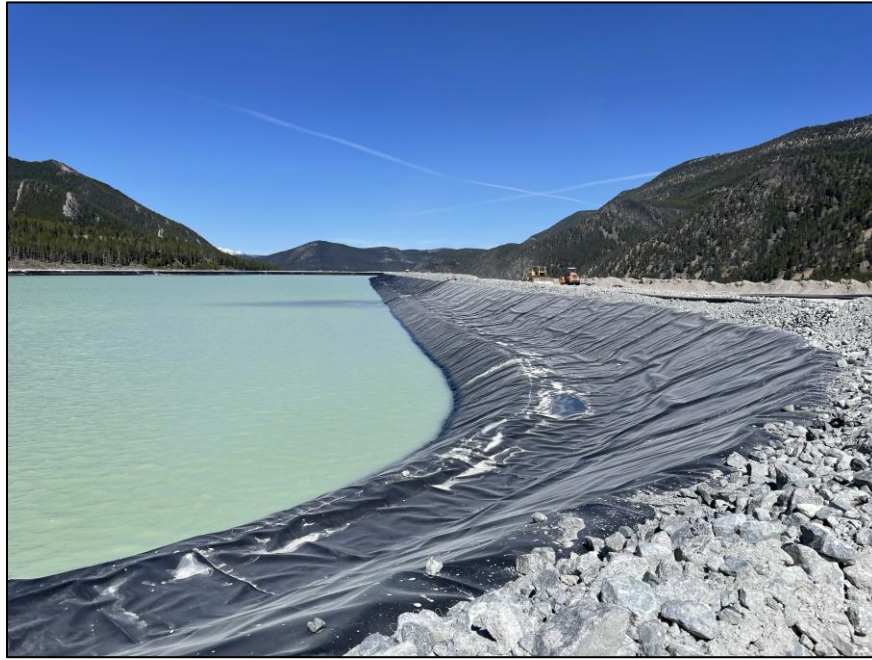
**PHOTO 3** - North Embankment upstream slope and crest looking northwest (May 2024).

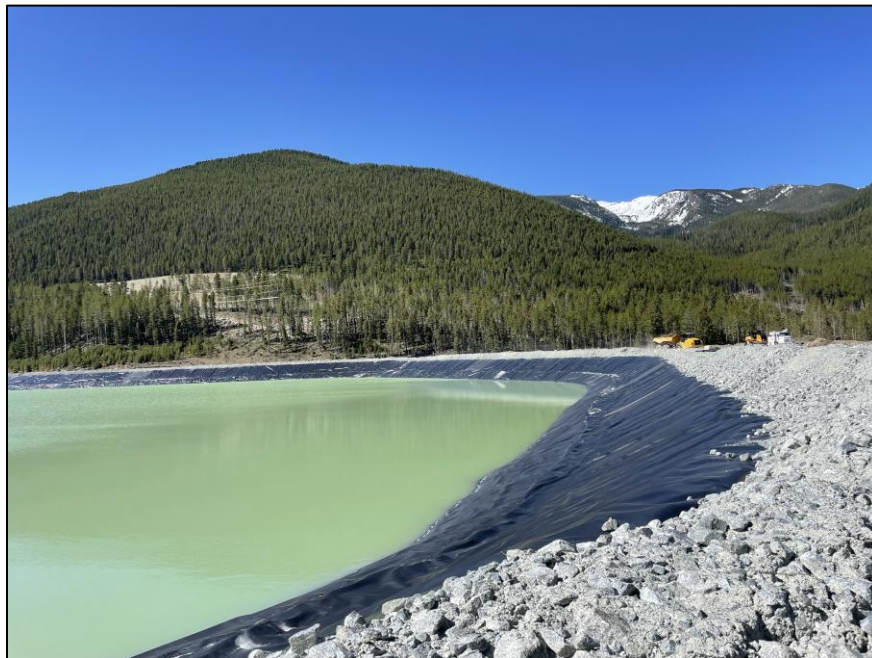
**PHOTO 4** - West Embankment upstream slope, looking south (May 2024).

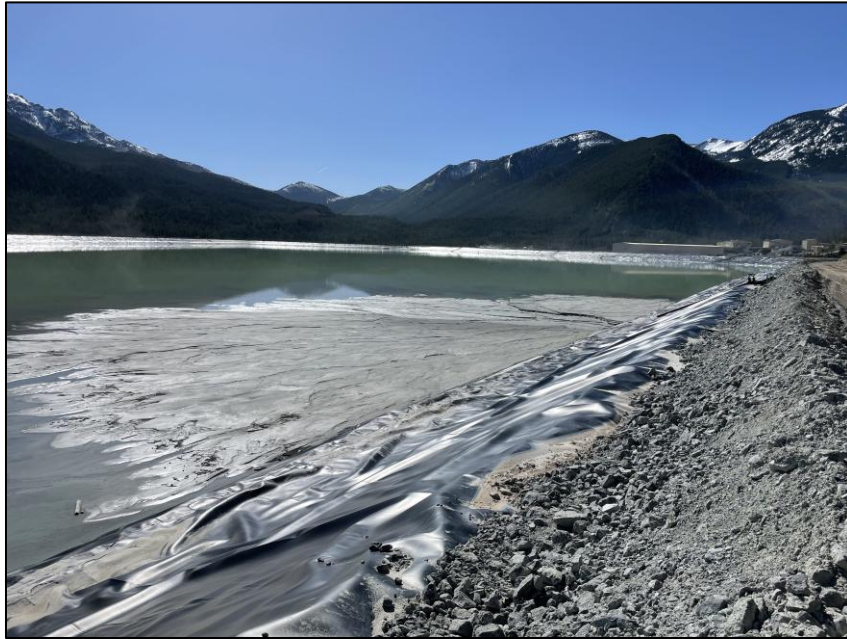
**PHOTO 5** - Southwest Embankment looking southeast (May 2024).

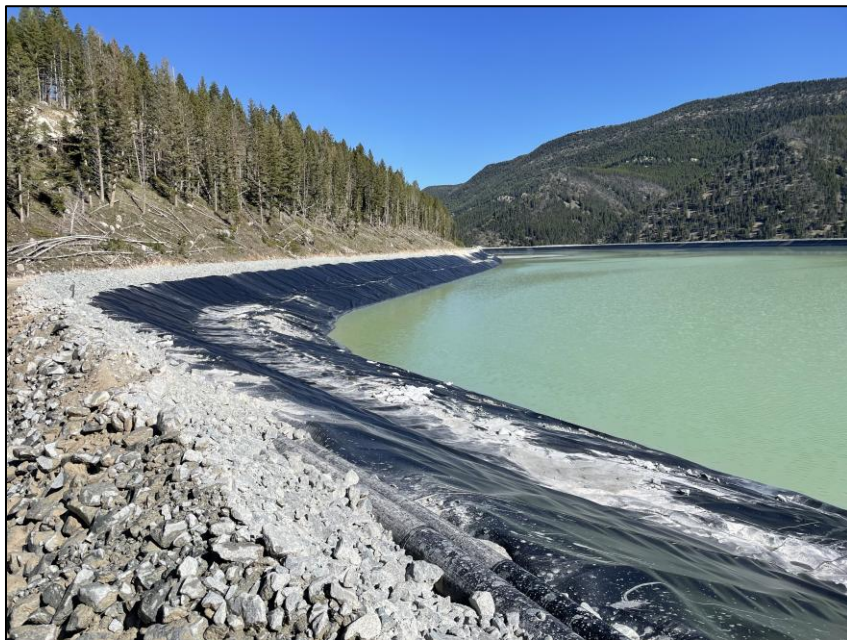
**PHOTO 6** - Upstream slope of Southwest Embankment, looking northwest (May 2024).

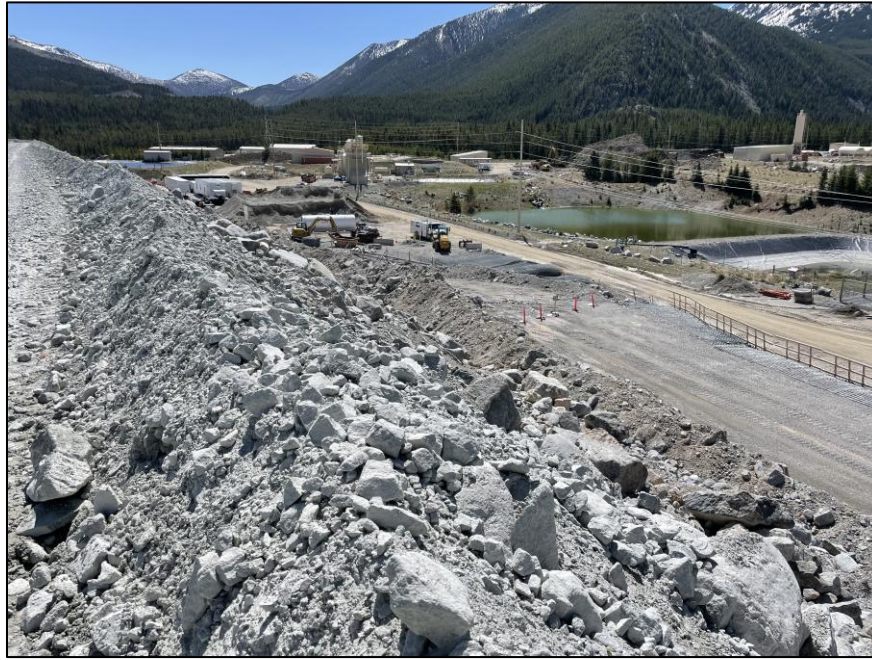
**PHOTO 7** - South Embankment downstream slope, looking southwest (May 2024).

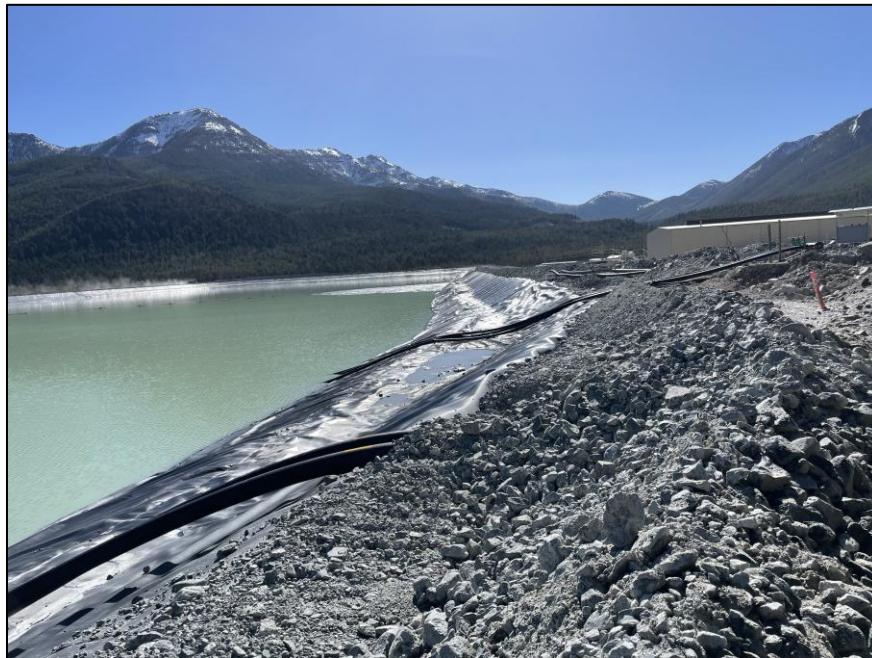
**PHOTO 8** - South Embankment upstream slope looking east (May 2024).

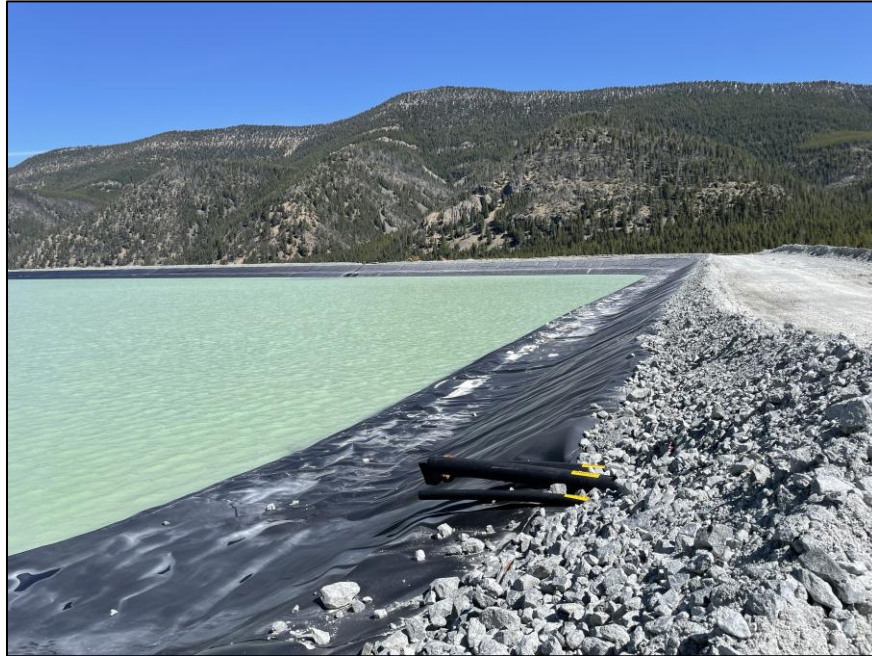
**PHOTO 9** - East Embankment upstream slope looking north (May 2024).

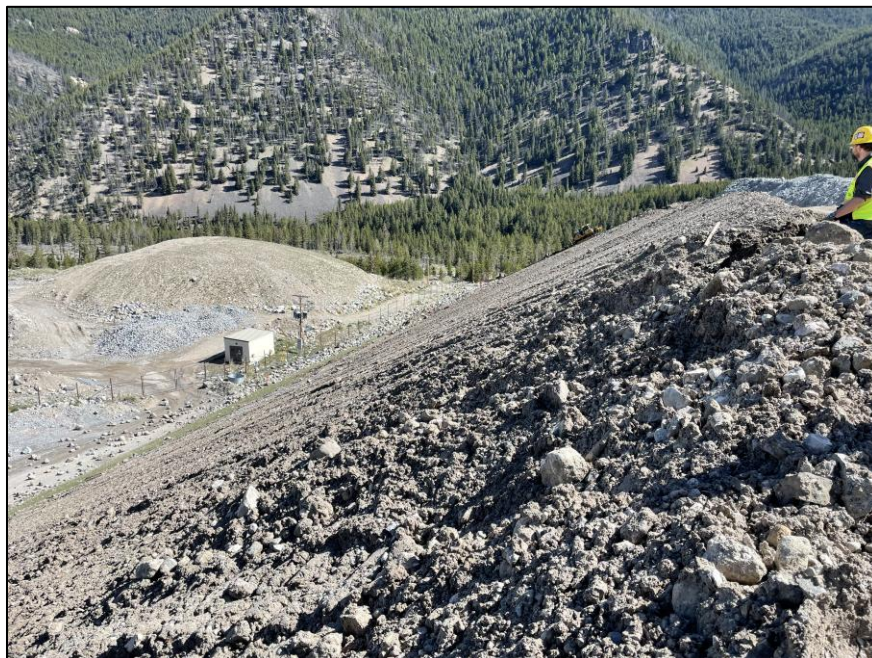
**PHOTO 10** – West Embankment downstream slope, looking north (May 2024).

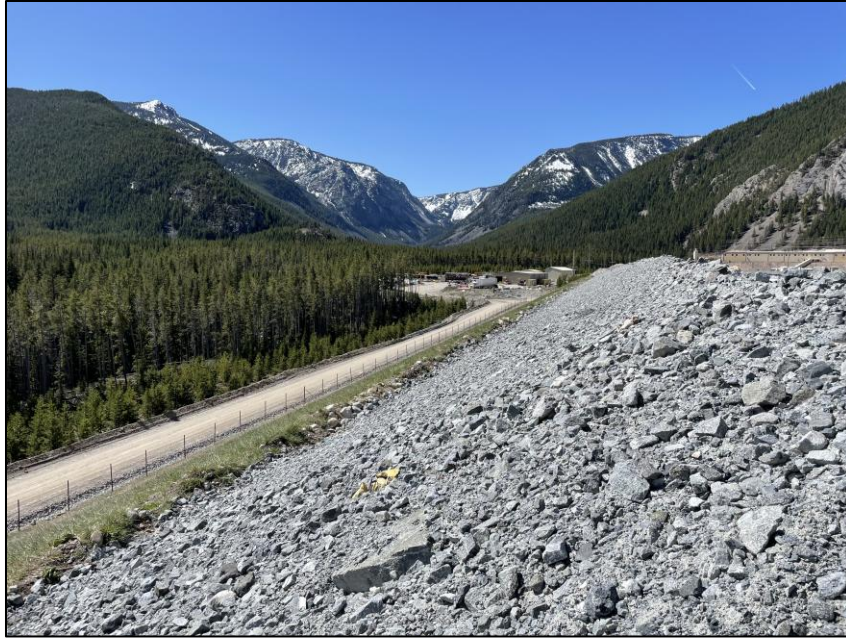
**PHOTO 11** - East Embankment, Stage 6 ROM rockfill and surface soil placement on outer slope, looking south (May 2024).

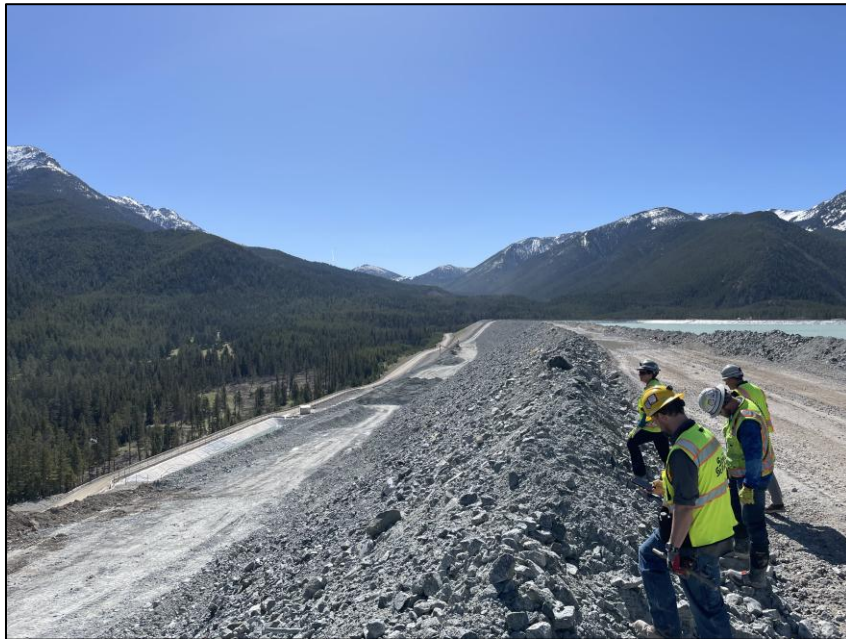
**PHOTO 12** - North Embankment, Stage 6 ROM rockfill placement, looking east (May 2024).

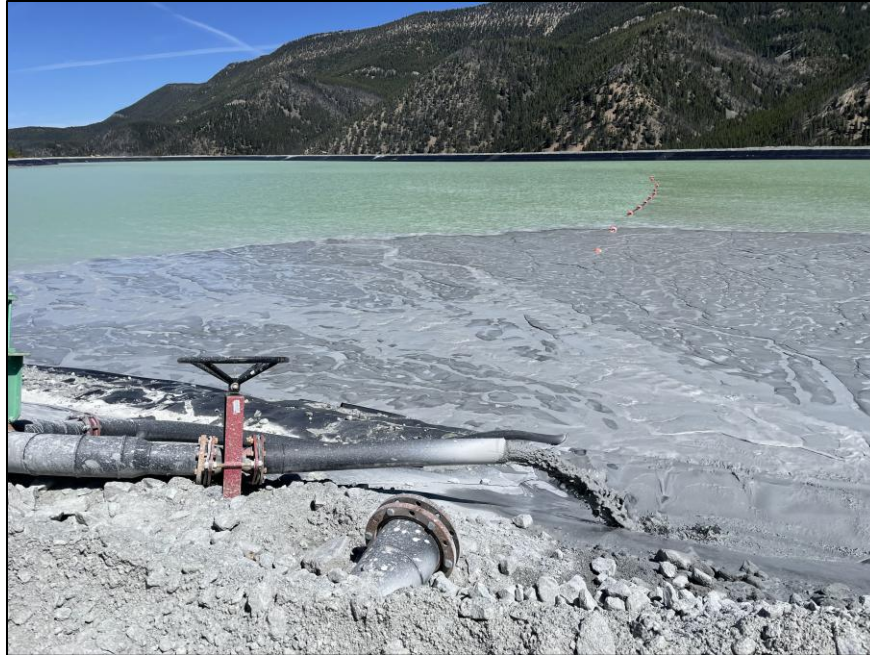
**PHOTO 13** – Tailings Discharge line from the Southeast Embankment, looking east (May 2024).

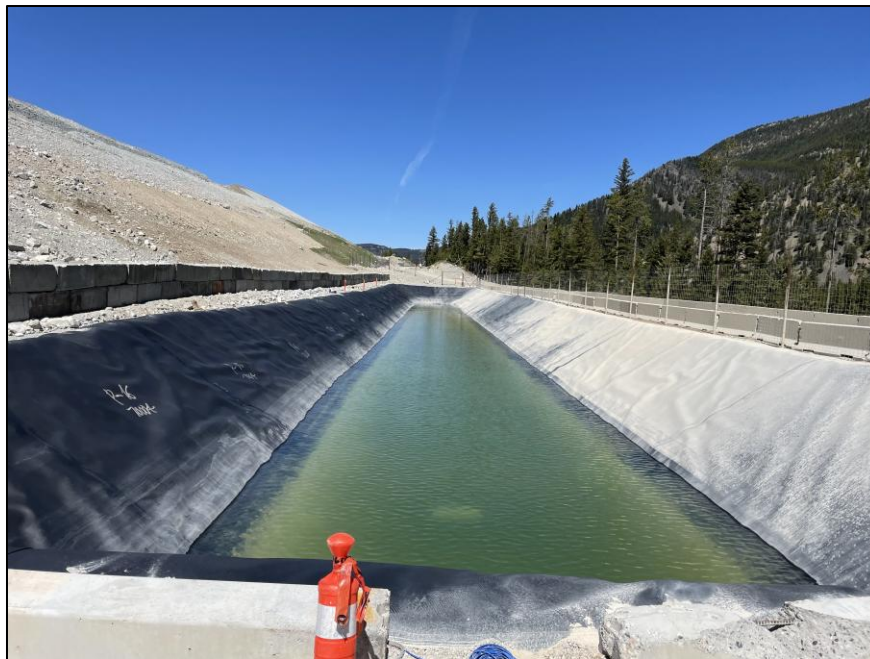
**PHOTO 14** – Relocated Embankment Underdrain Collection Pond looking west (May 2024).
