DECEMBER 2022

MARIKANA TAILINGS  
 STORAGE FACILITY (TSF)

DETAILS OF TAILINGS STORAGE FACILITY

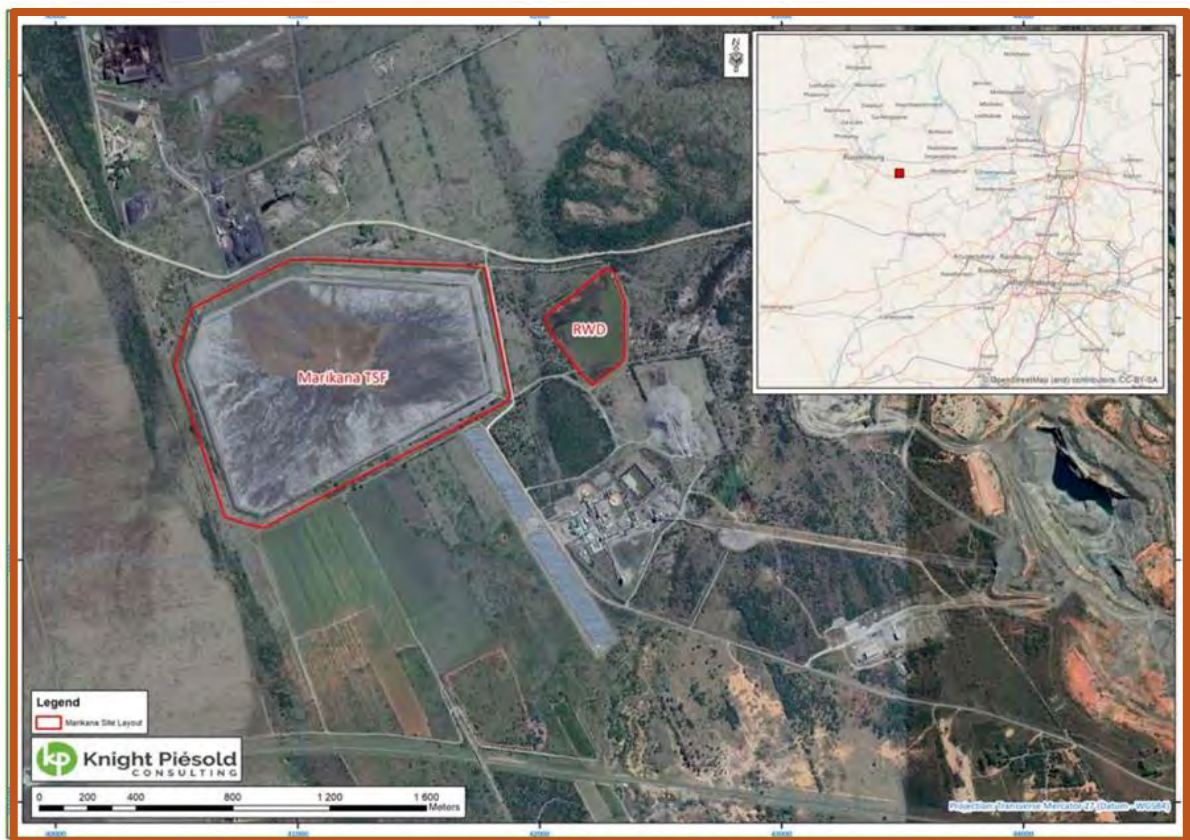
Figure 1: Layout of Marikana TSF
