# EAST BOULDER MINE - TAILINGS STORAGE FACILITY EMERGENCY PREPAREDNESS PLAN (EPP)

### East Boulder Mine - Tailings Storage Facility Emergency Preparedness Plan (EPP)

2022/12/19

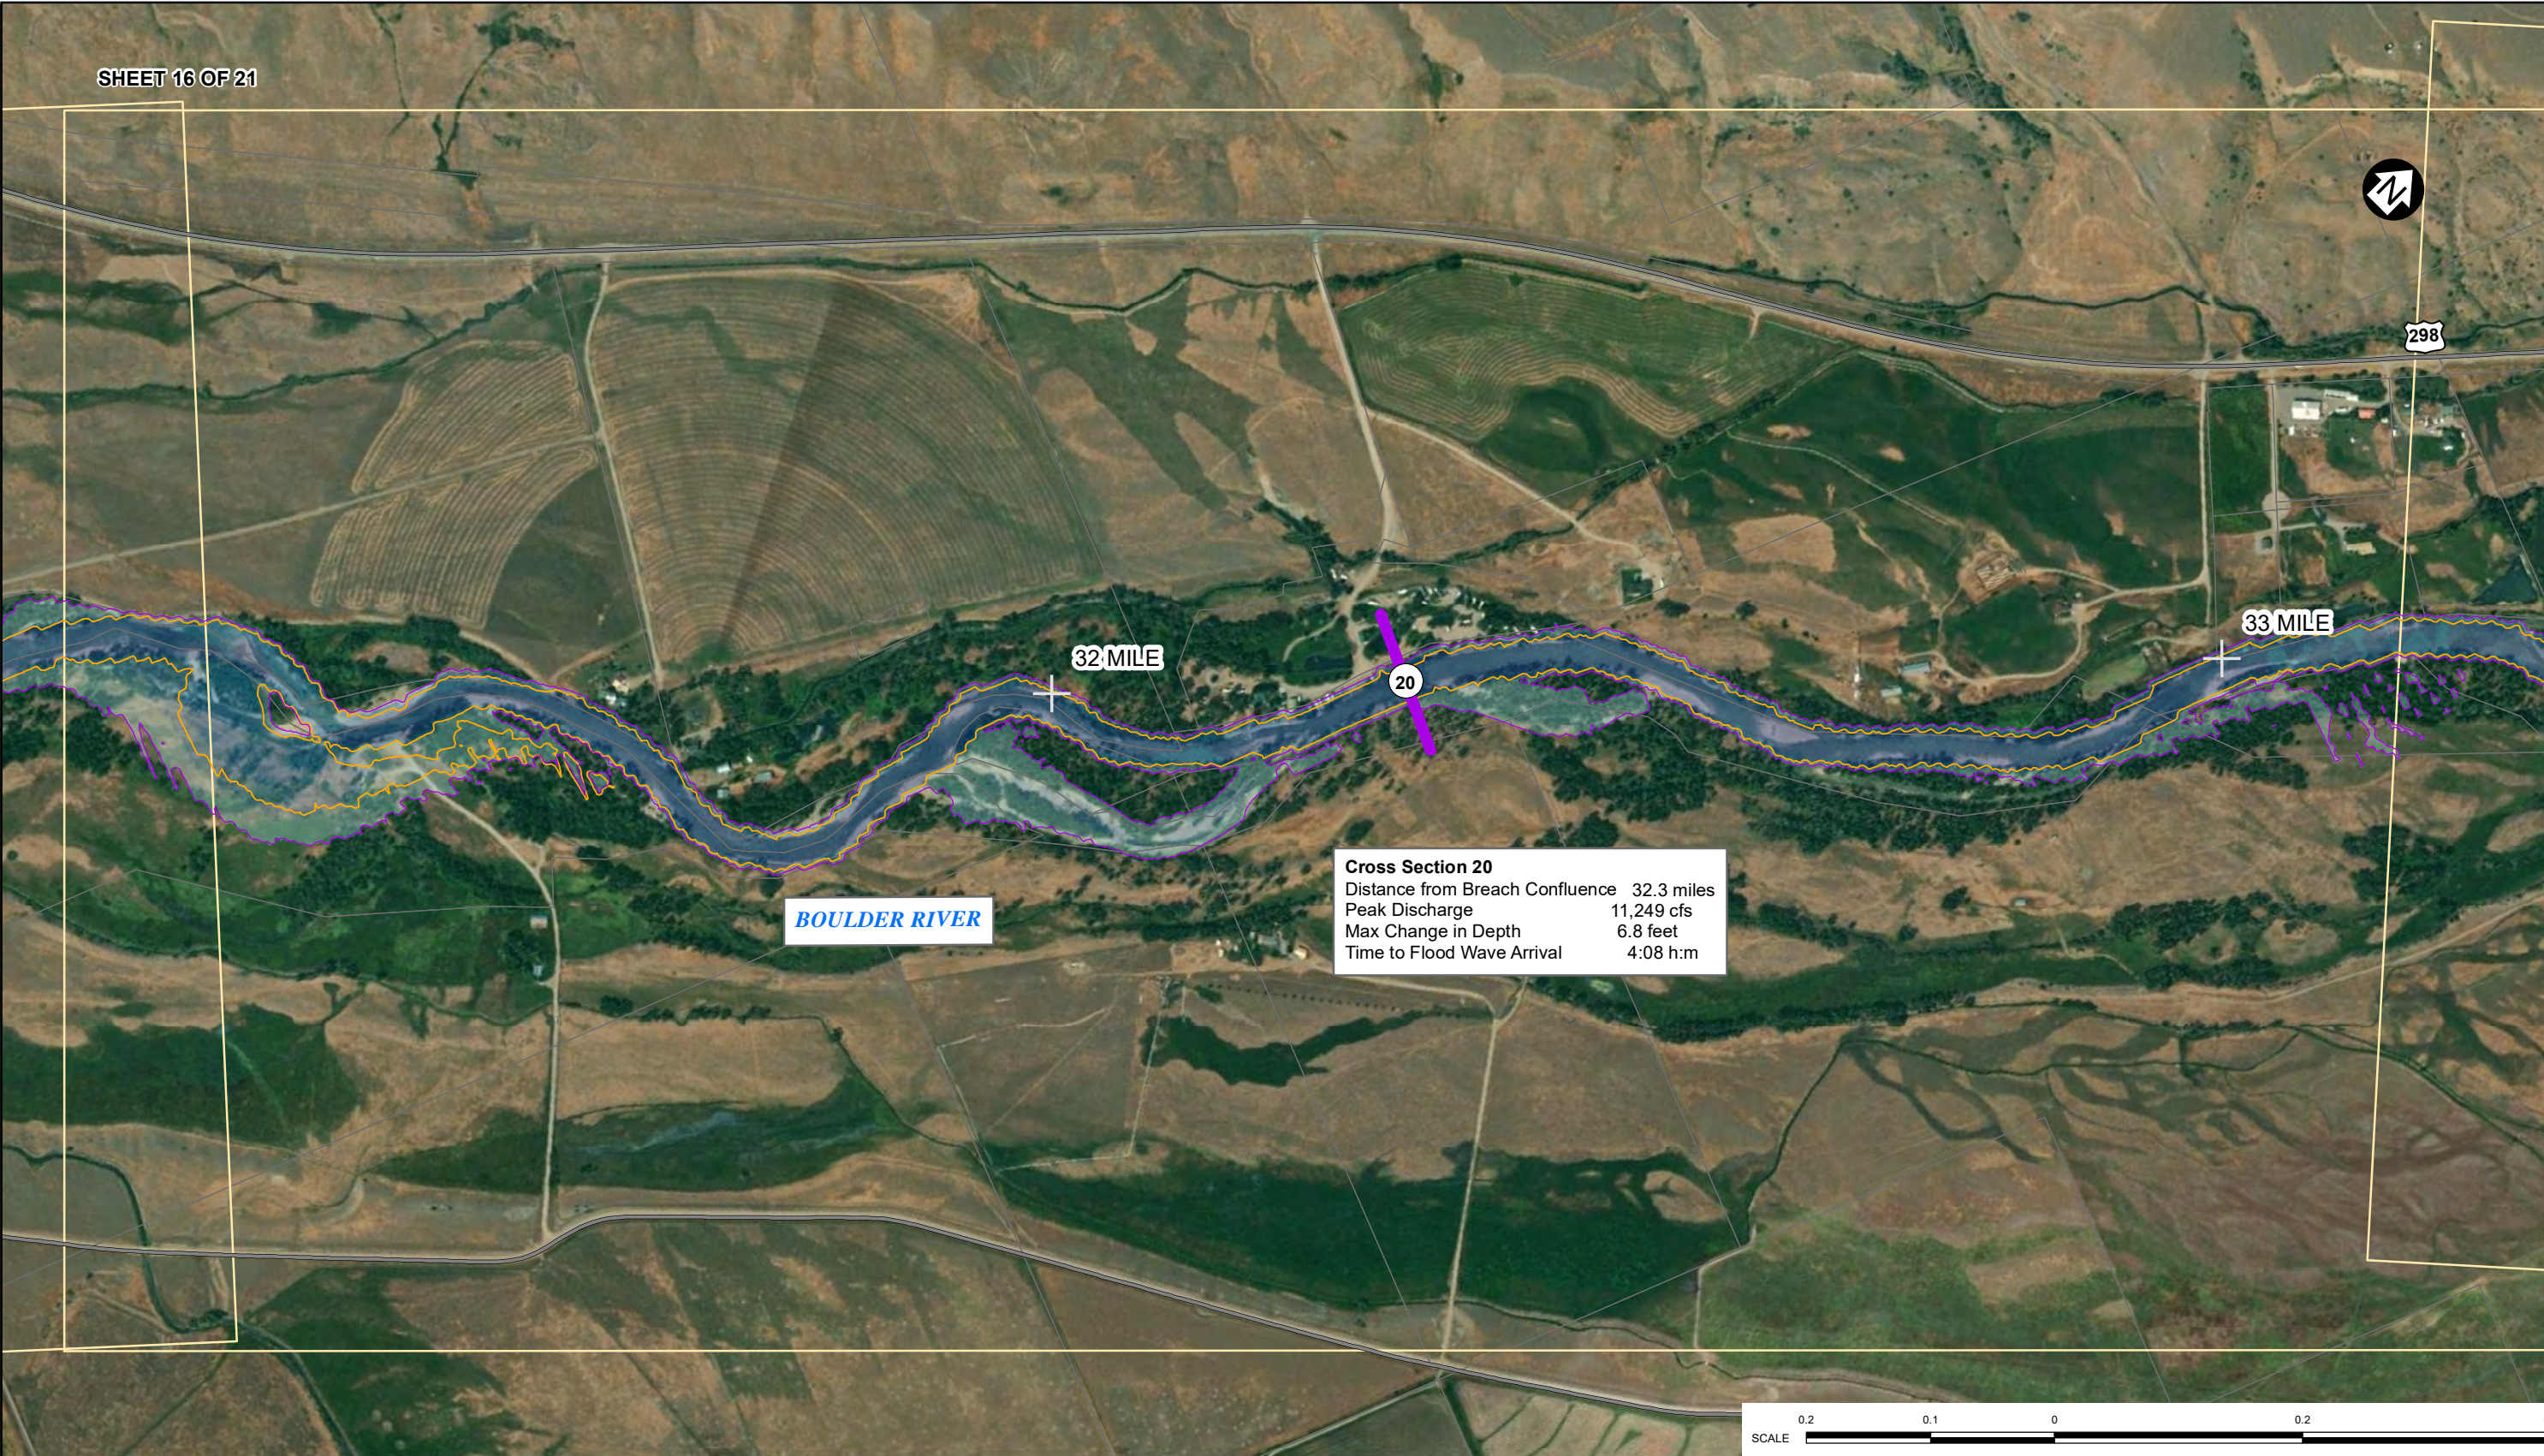
**Cross Section 20**  
Distance from Breach Confluence 32.3 miles  
Peak Discharge 11,249 cfs  
Max Change in Depth 6.8 feet  
Time to Flood Wave Arrival 4:08 h:m
