DETAILS OF TAILINGS STORAGE FACILITY

Beatrix TSF 2 (BTX2)

Operation Beatrix

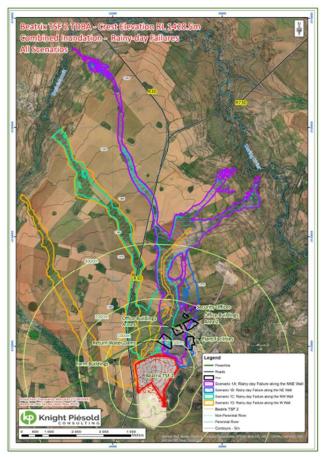
Figure 2: Consolidated view of the rainy-day failure scenario inundation boundaries

Has been identified by EoRs – please refer to Figures 2 & 3

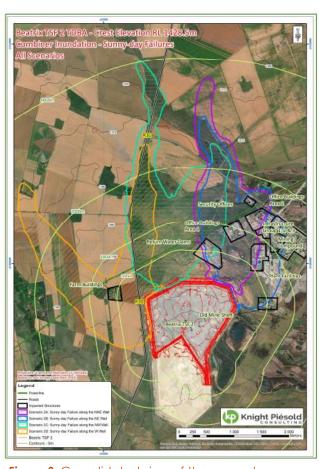
Figure 3: Consolidated view of the sunny-day failure scenario inundation boundaries
