GLOBAL INDUSTRY STANDARD FOR TAILINGS MANAGEMENT – DECLARATION OF CONFORMANCE

This document serves to outline the approach followed towards conformance and provides a summary of the conformance status of all TSFs owned and managed by Sibanye Stillwater Limited (Sibanye-Stillwater or the Group) as of 31st July 2023.

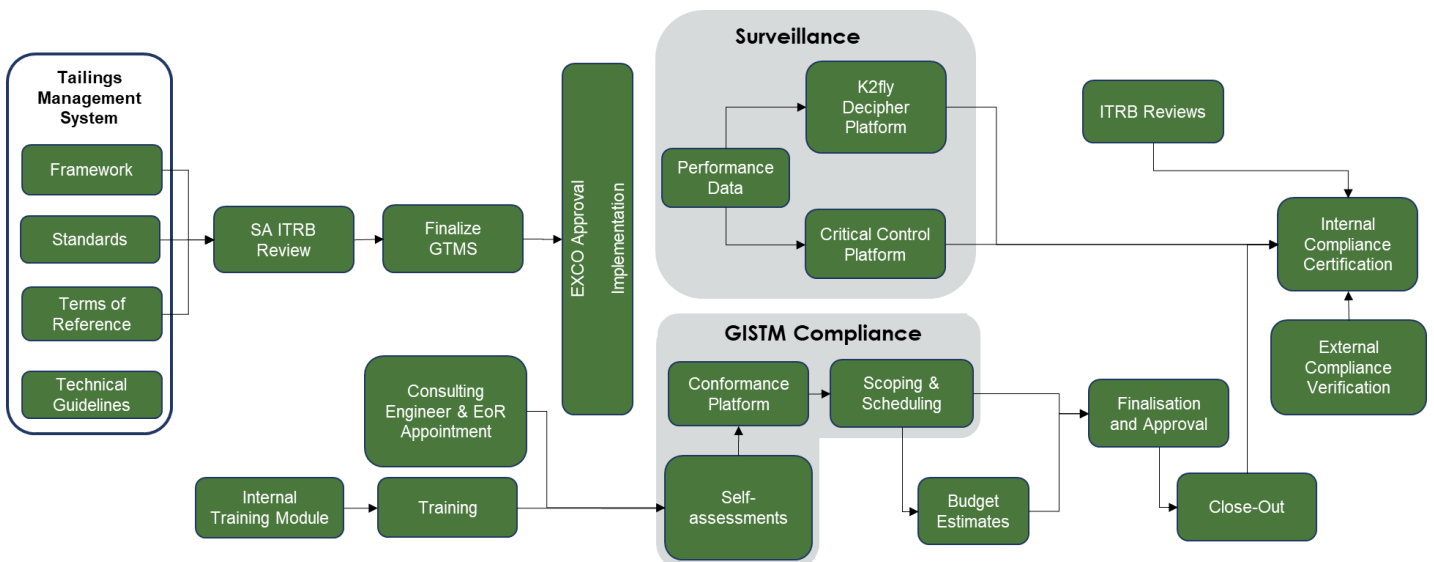
FIGURE 2-1: CONFORMANCE ROADMAP

An internal road map was initially established to identify the high-level gaps and actions required for conformance. A Group Tailings Management System (GTMS), aligned to the GISTM, was developed, reviewed by the SA Region's Independent Tailings Review Board (ITRB) and approved by the Executive and Board. All further actions were undertaken in accordance with the GTMS. A summary of the roadmap is included in Figure 2-1.
