#### **JUNE 2025**

## BAOBAB TAILINGS STORAGE FACILITY (TSF)

### **DETAILS OF TAILINGS STORAGE FACILITY**

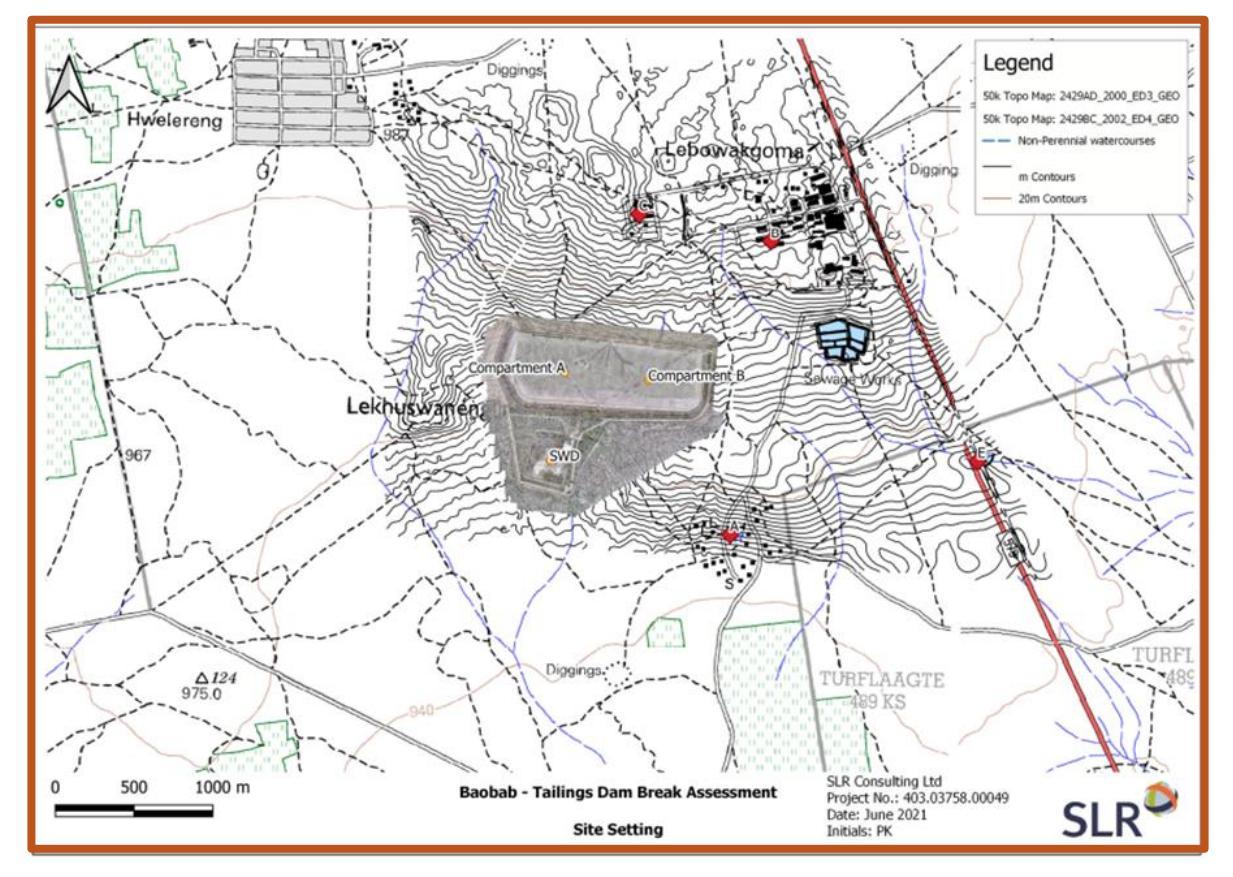
Figure 1: Layout of Baobab TSF

Baobab
Limpopo
Mogalakwena Platinum (Potgietersrus) Mining Operation (MPMO) owned by Anglo-American Platinum (AAP)
Active
RSA - PGM
50 km south of the city of Polokwane, and about 60 km southeast of Mokopane in Limpopo Province - please refer to Figure 1
-24.3698, 29.4712
Underground
Impoundment (upstream development)
Spigot with a possibility of converting to a hybrid paddock system
2002
Very High
Minopex
SLR Consulting (Pty) Ltd
18
40
95 000
7.9
2029 @1.6m/yr

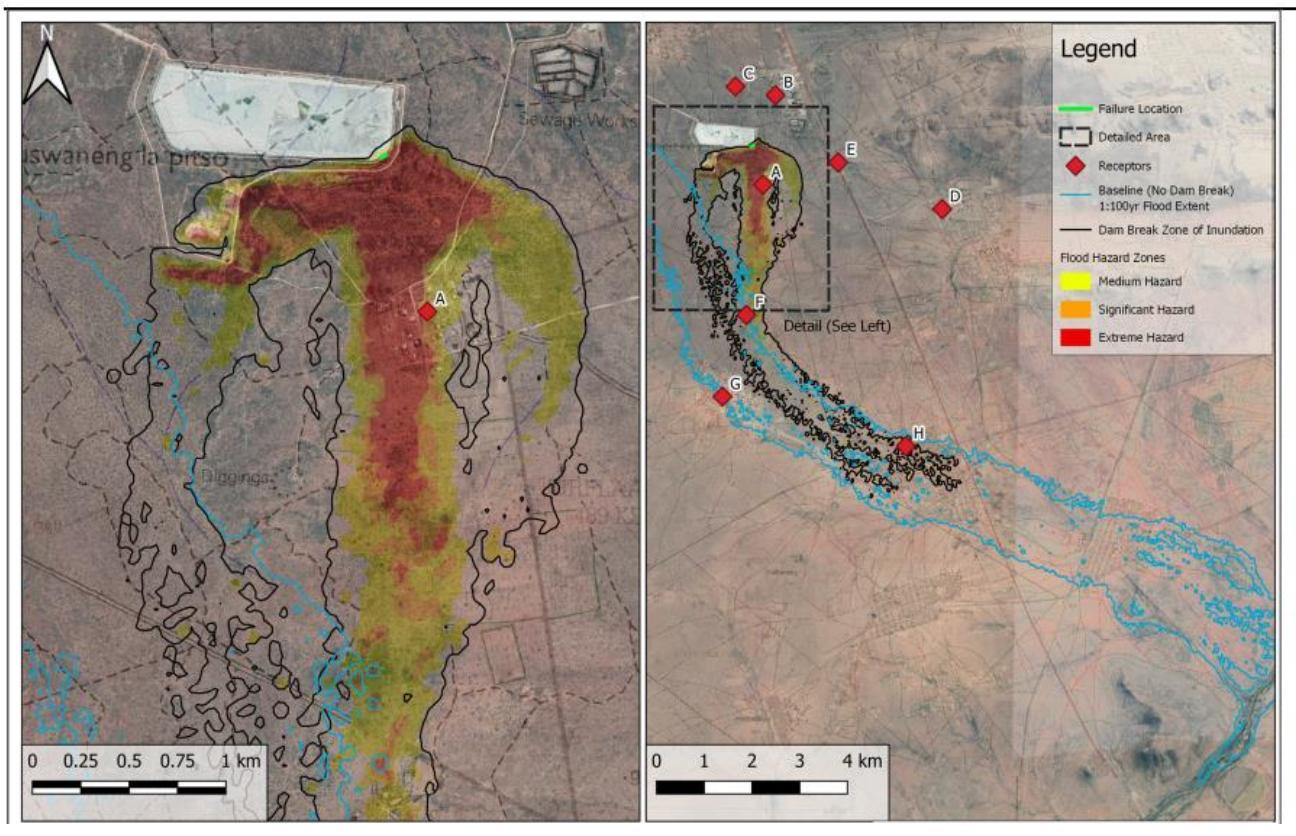
Figure 2: East Failure Area of Inundation

Has been identified by EoRs – please refer to Figure 2 to 4

Consequence classification has been based on Population at Risk (PAR). Communities have been identified and are being engaged through various means. An appointed external specialist has conducted vulnerability assessments for communities located within the Area of Inundation
