JULY 2025

PRINCESS CREEK TAILINGS  
STORAGE FACILITY (TSF)

DETAILS OF TAILINGS STORAGE FACILITY

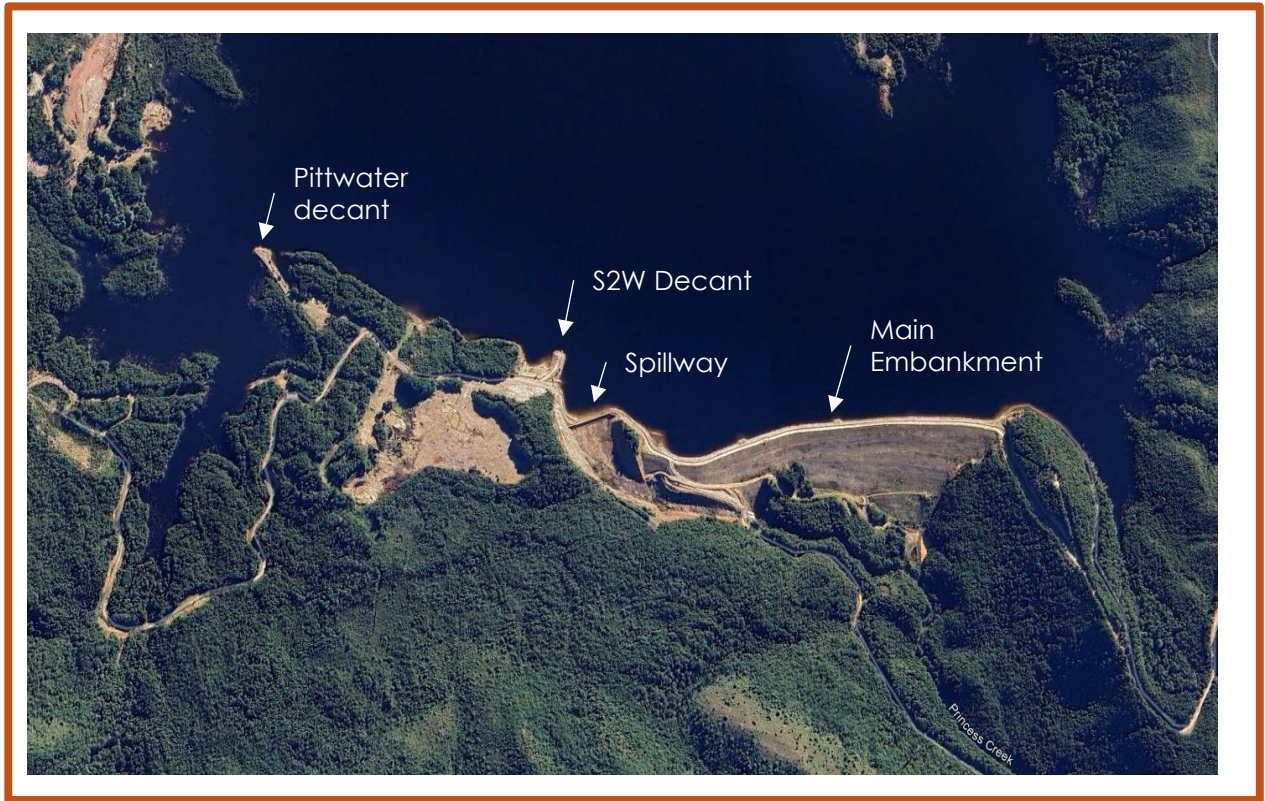
**Figure 1:** Layout of Princess Creek TSF
