EZULWINI NORTH TAILINGS
 STORAGE FACILITY (TSF)

DETAILS OF TAILINGS STORAGE FACILITY

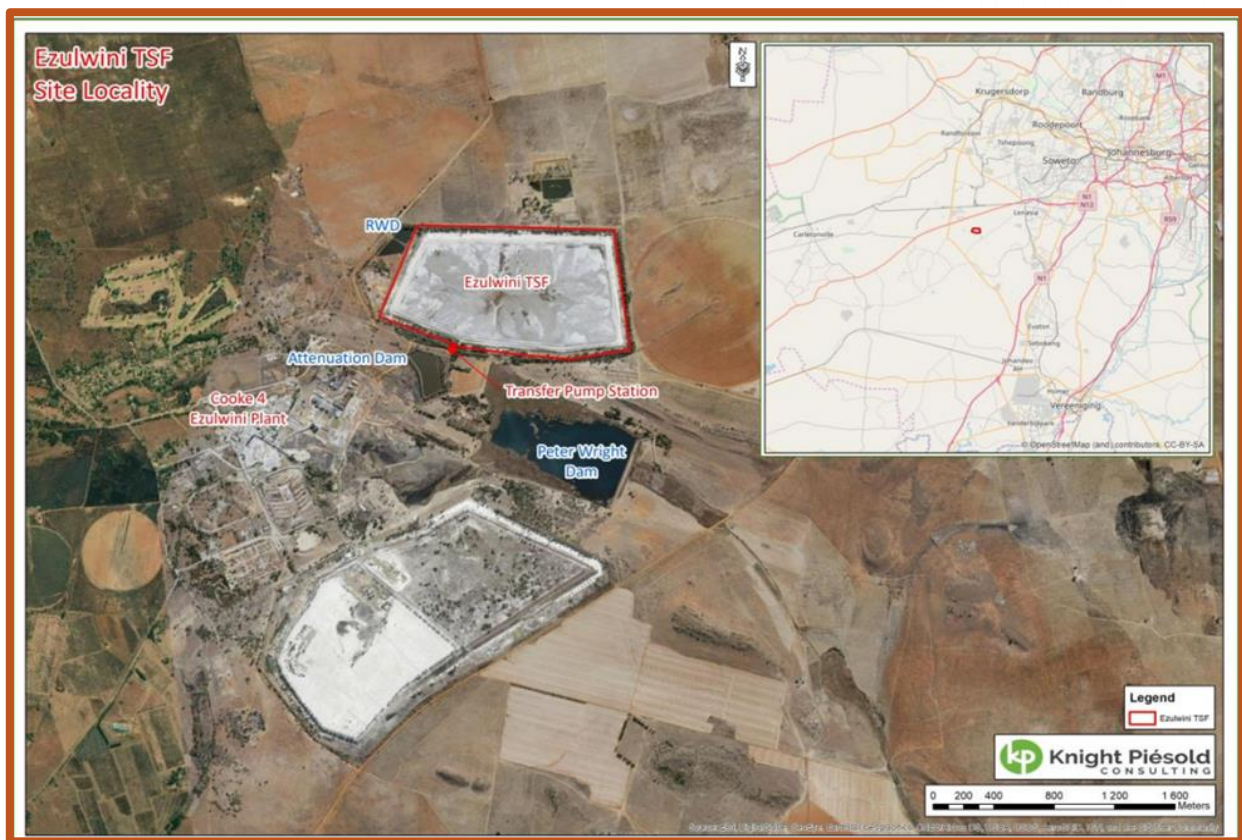
Figure 1: Layout of Ezulwini (Cooke 4) TSF Complex

| Location | Westonaria, South-west of Johannesburg - please refer to Figure 1 |

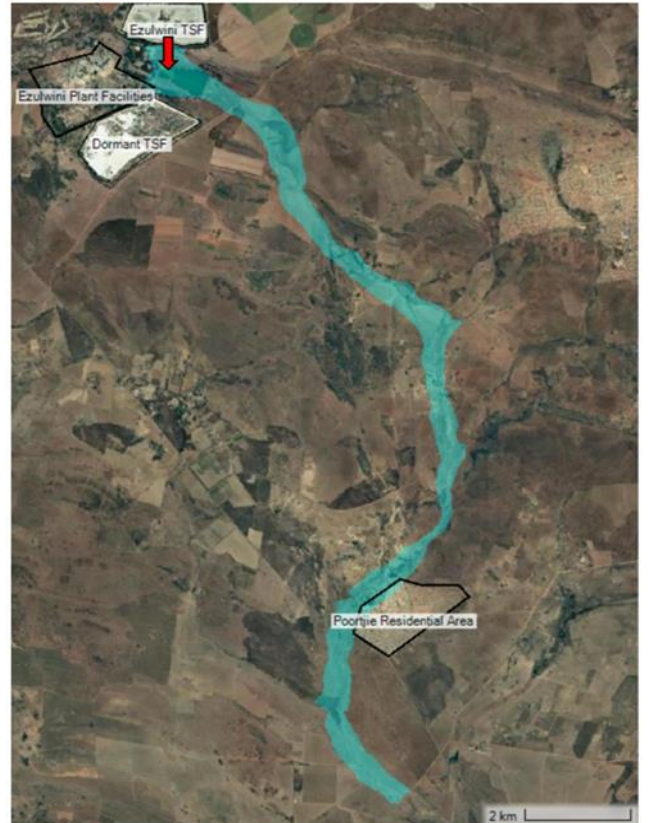
Figure 3: Inundation Map for the Rainy-day Failure at the Southern Wall

Has been identified by EoRs – please refer to Figures 2 to 5

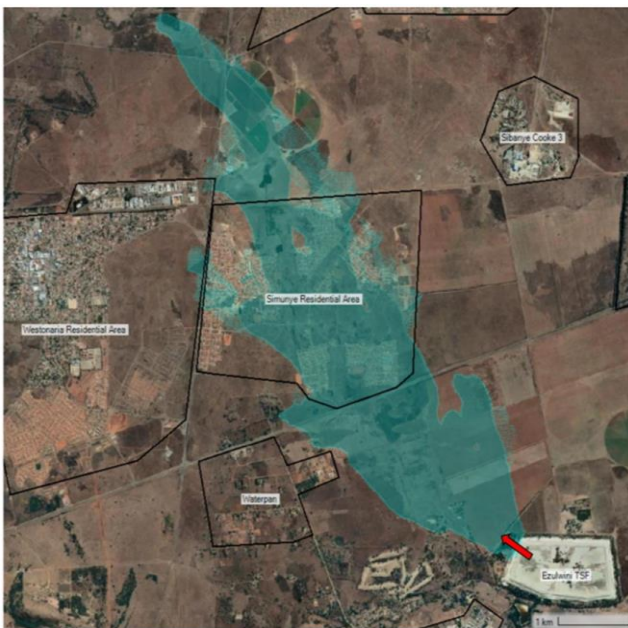
Figure 4: Inundation Map for the Rainy-day Failure at the North-Western Wall

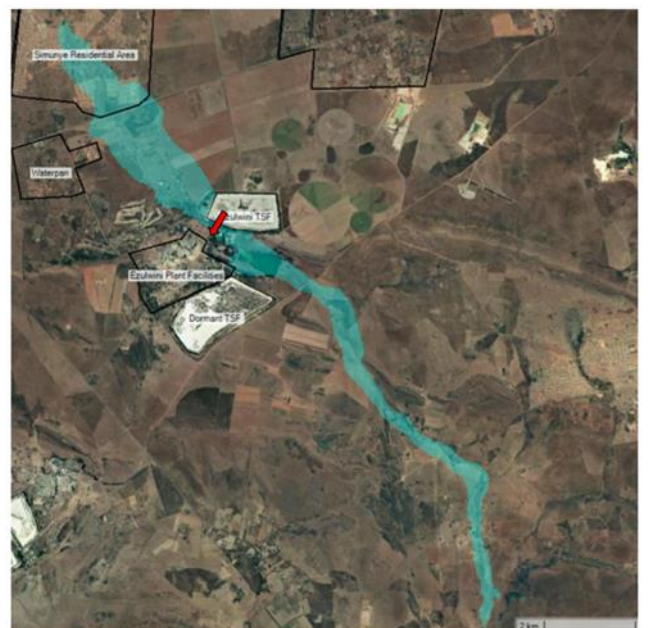
Figure 5: Inundation Map for the Rainy-day Failure at the South-Eastern Wall
