DETAILS OF TAILINGS STORAGE FACILITY

Leeudoorn TSF (upper and lower)

Operation Kloof 2
Operational Status Active

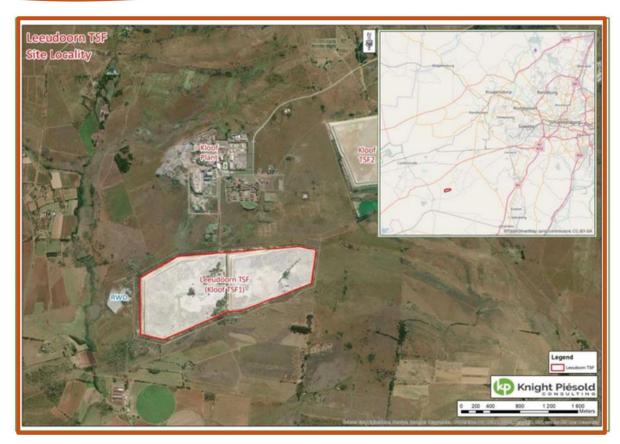
Figure 1: Layout of Leeudoorn TSF

7 km north-east of Fochville in West Rand - please refer to

Figure 1

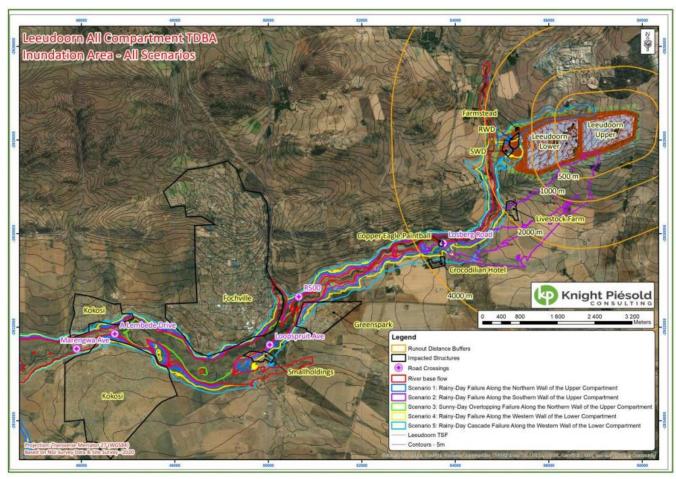
Figure 2: Consolidated view of all scenarios inundations boundaries

Assessment completed in 2022 (KP Reference: RI301-00840/06 Rev B, 21 September 2022)

Has been identified by EoRs – please refer to Figure 2
