WESTERN PLATINUM MINE TAILINGS STORAGE FACILITY (TSF) 5

DETAILS OF TAILINGS STORAGE FACILITY

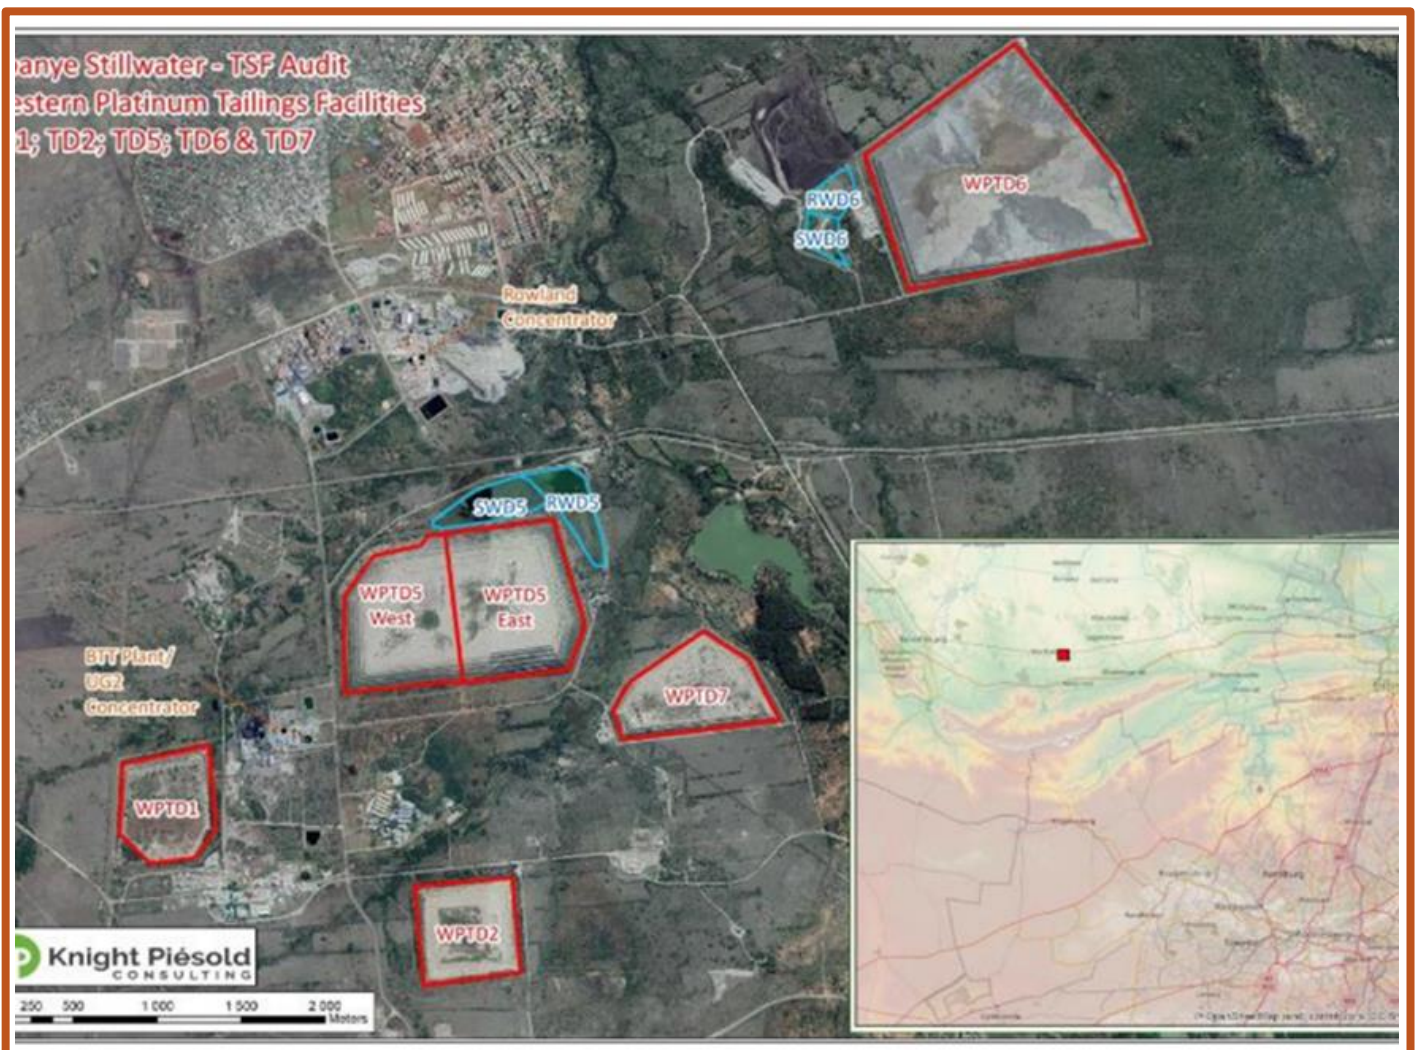
Figure 1: Layout of Western Platinum (WPL) Tailings Dam Complex

Tailings Storage Facility (TSF) Name	Western Platinum Tailings Dam Complex - Tailings Dam 5 (WPL TD5)
Operation	Marikana
Operational Status	Dormant since 2017
Operating Segment	RSA - PGM
Location	5 km east of the town of Marikana in the North-West province – please refer to Figure 1
Latitude, Longitude (decimals)	-25.6968, 27.5264
Ore Source	Underground
Type of Storage Facility	Impoundment (upstream development)
Deposition Methodology	Spigot
Year of Commissioning	1980
Consequence Classification (GISTM, 2020)	Extreme
Operating Contractor	Fraser Alexander (Pty) Ltd (FAT)
Engineer of Record (EoR)	SLR Consulting (Pty) Ltd
Current Maximum Height (m)	63
Final Maximum Height (m)	63
Total Volume Already Deposited (Mm³)	45.1
Life of TSF (year)	N/A

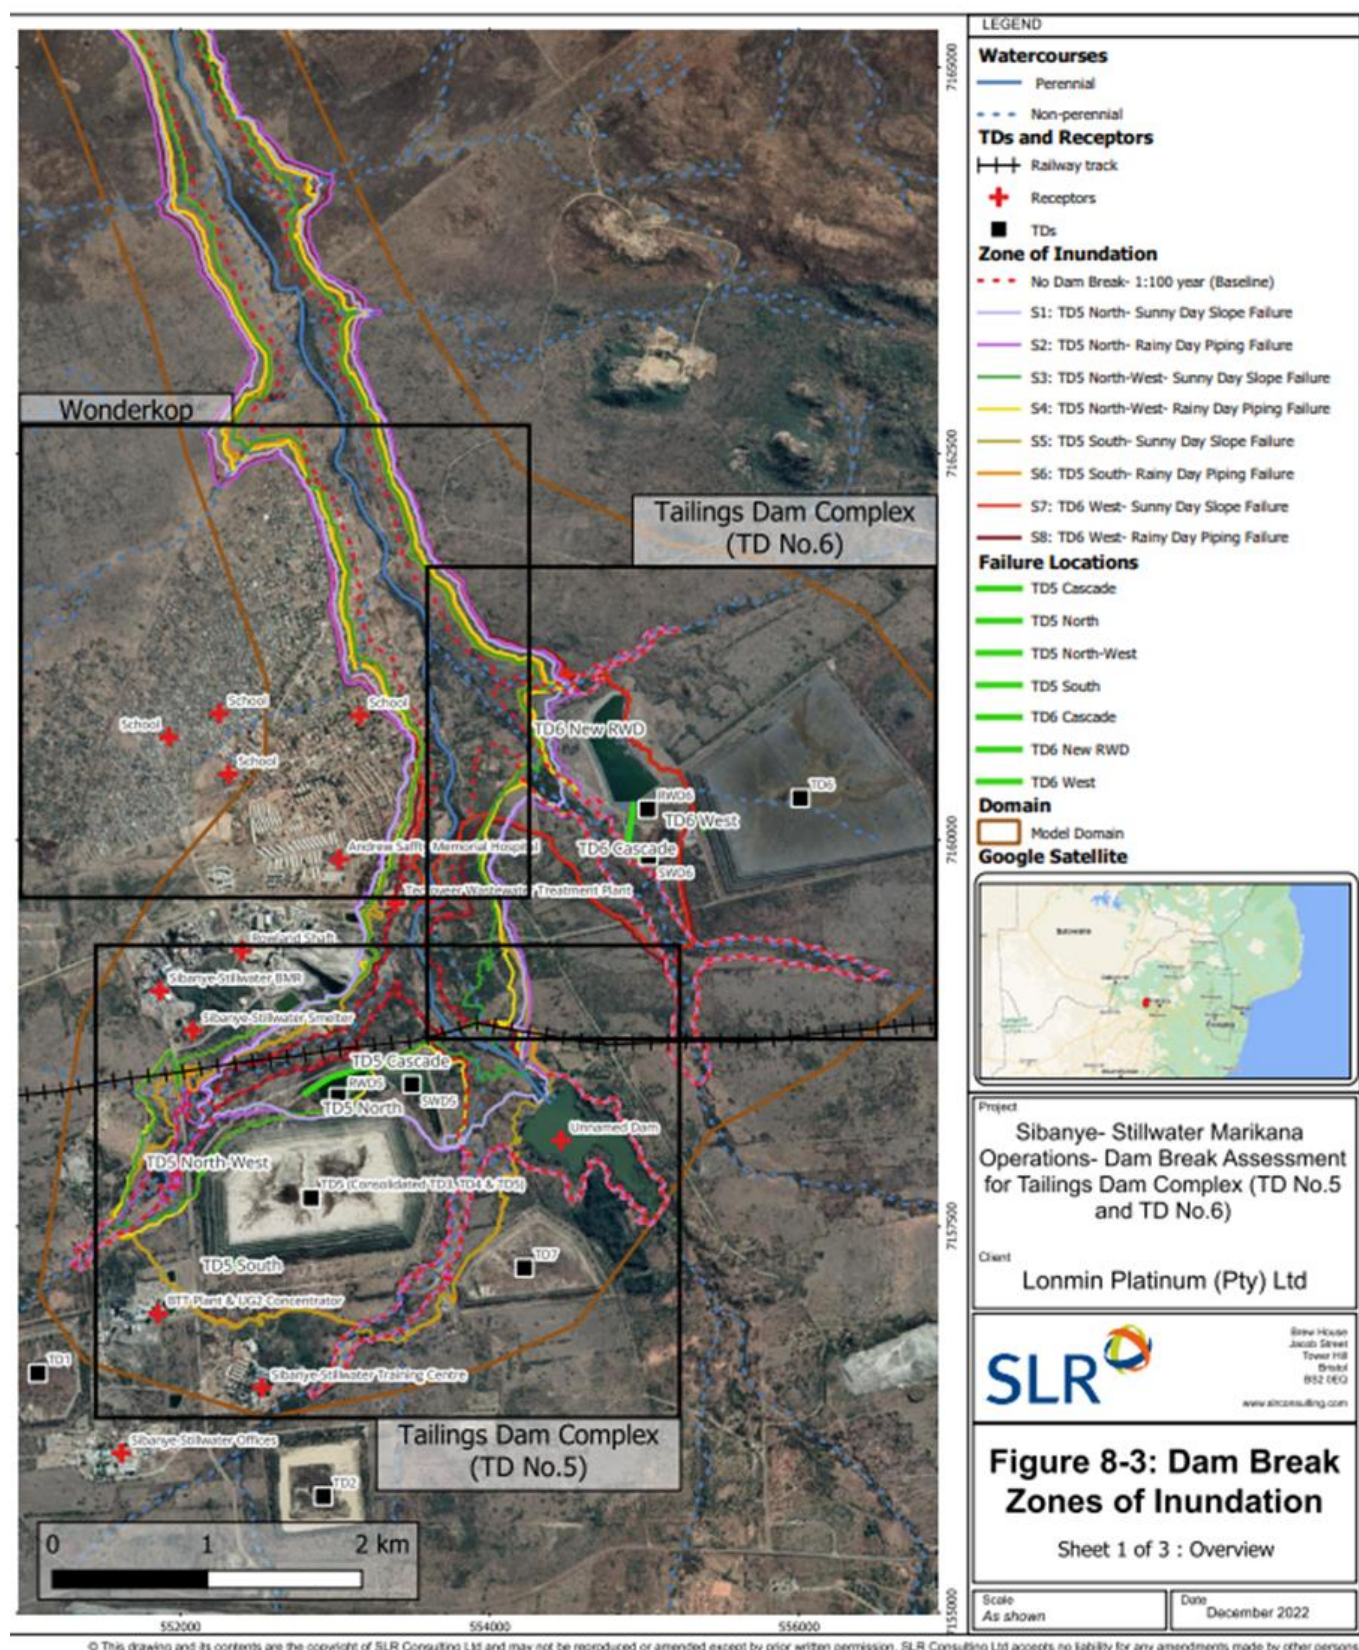
Figure 2: Summary of Area of Inundation for All Scenarios

Has been identified by EoRs – please refer to Figure 2
